# Deterioration Indicator

RH-23

Visually check for deterioration or malfunction of power distribution equipment day and night

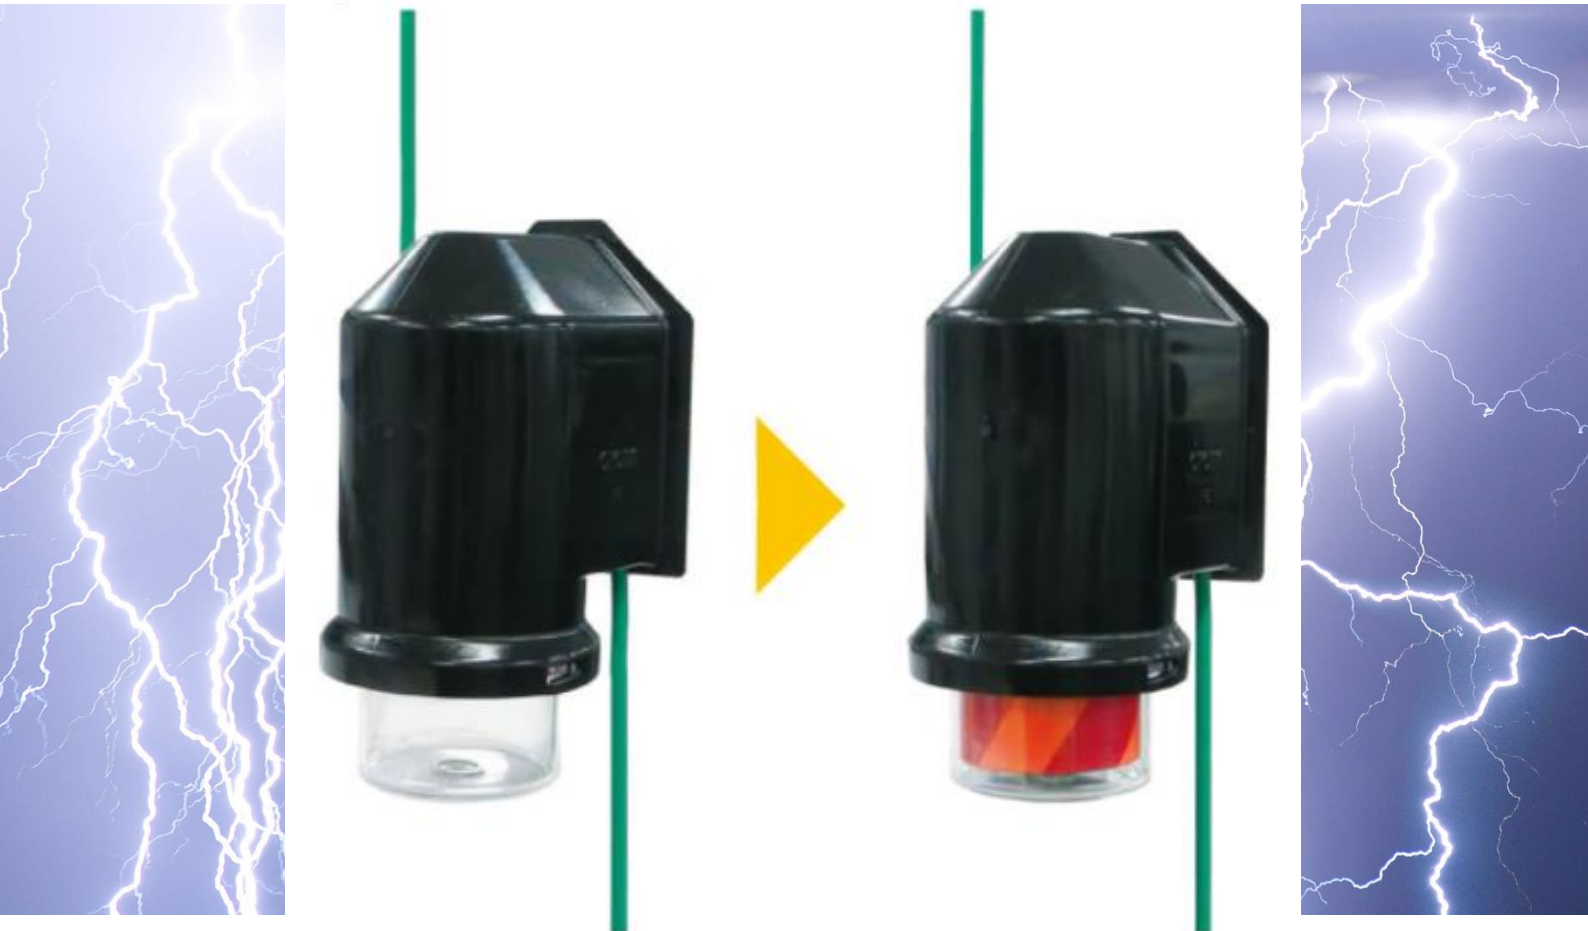
When power distribution equipment such as transformers, switchgear, and surge arresters deteriorate or fail, the deterioration indicator (red fluorescent sheet and reflective sheet) protrudes.

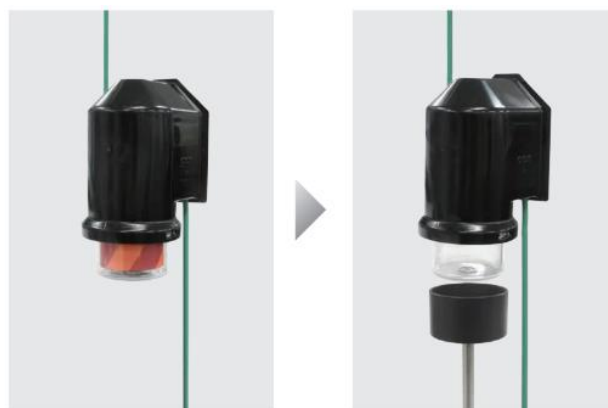
## How to use the return stick

The deterioration indicator can be restored by using the Return rod for the degradation indicator (Separately sold item Return rod type: RH-FK23).
